# Hunstanton Coastal Defences Update

Dave Robson & Jade Kite  
April 2026

Borough Council of  
**King's Lynn &  
West Norfolk**

# Hunstanton Emergency Repair Works

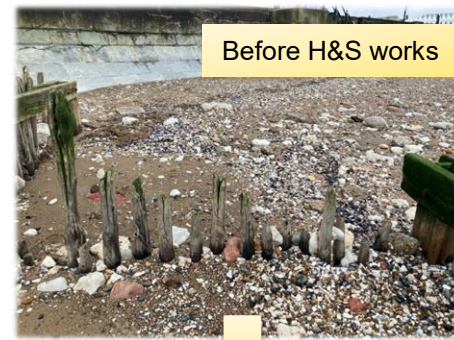
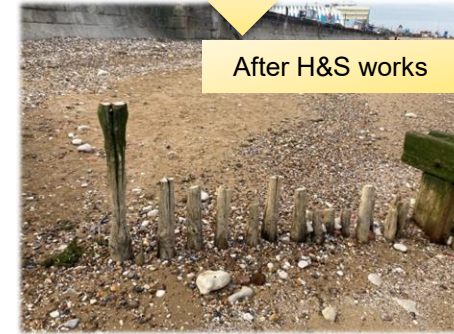
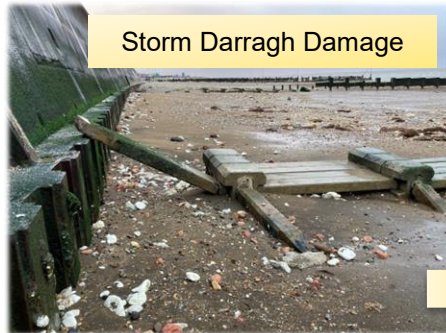
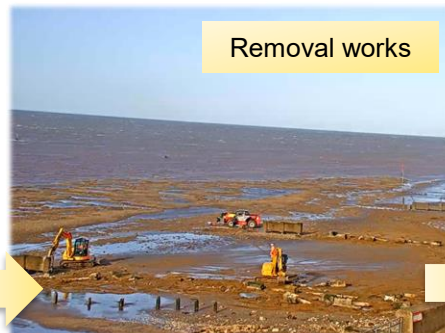
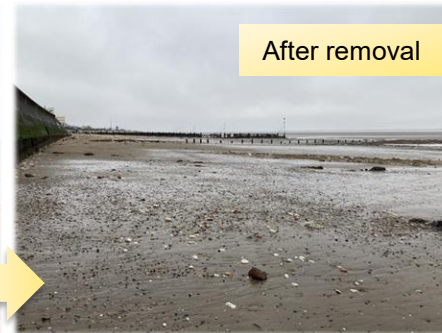
- Following completion of the groyne assessment, we have been maintaining the timber and concrete groynes from a health and safety perspective
- Regular inspections are undertaken to inform works required including:
  - Cutting pointed timber stakes flat when they develop a pointed end (see right)
  - Securing loose timber groyne elements, and where this is no longer possible, removing them
  - Removal of concrete groynes when they are at risk of falling over or undermined (see below)

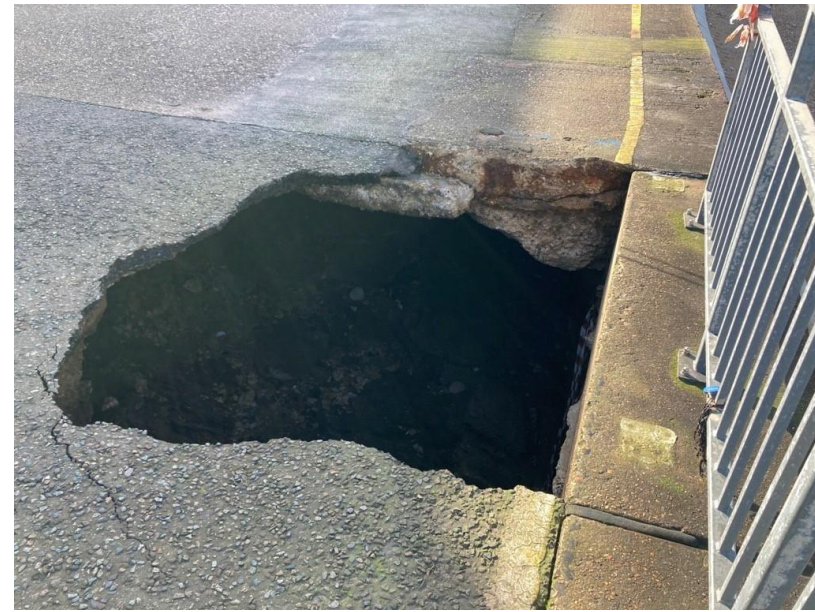
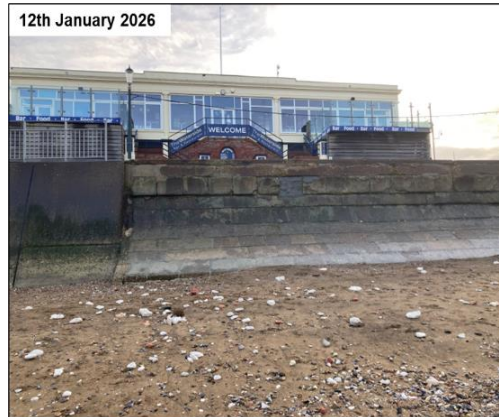
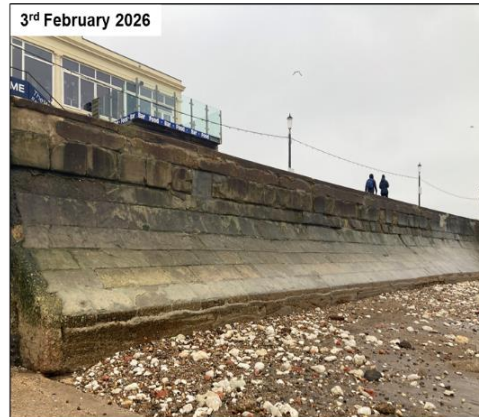
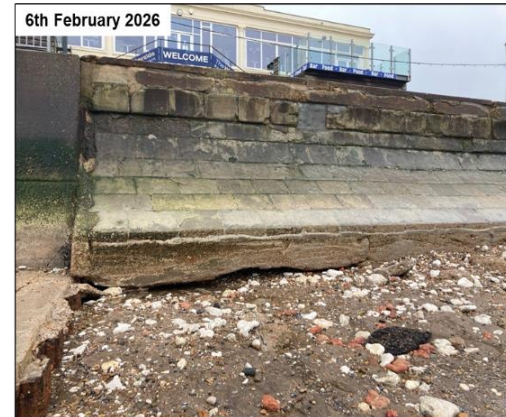
- High tides combined with strong winds between the 4<sup>th</sup> – 5<sup>th</sup> February caused around 20-30cm of beach material to be eroded.
- Waves travelled beneath the base of the seawall, washing out internal fill leading to a void forming.
- The void resulted in a lack of structural support to the promenade, and a hole formed at the surface.

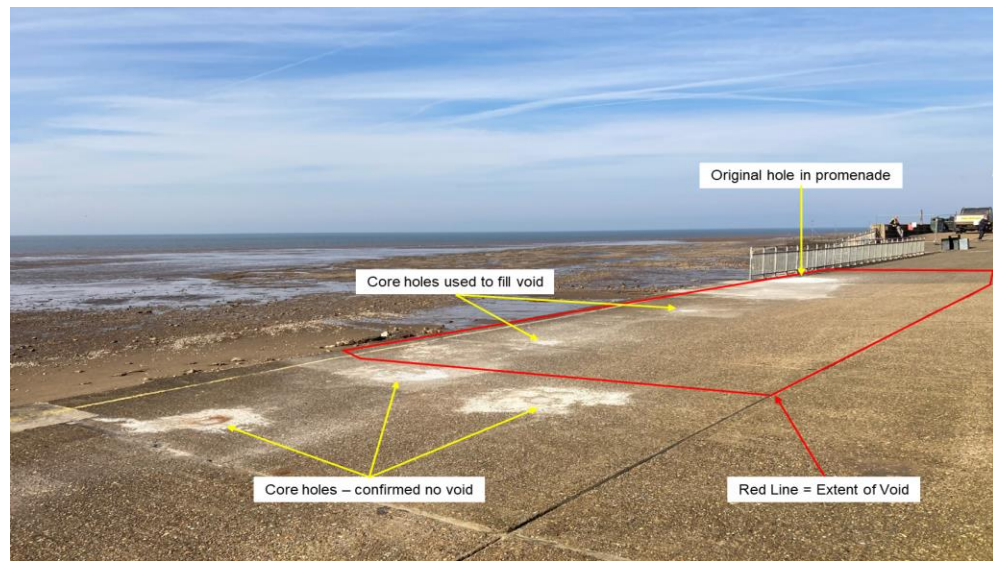
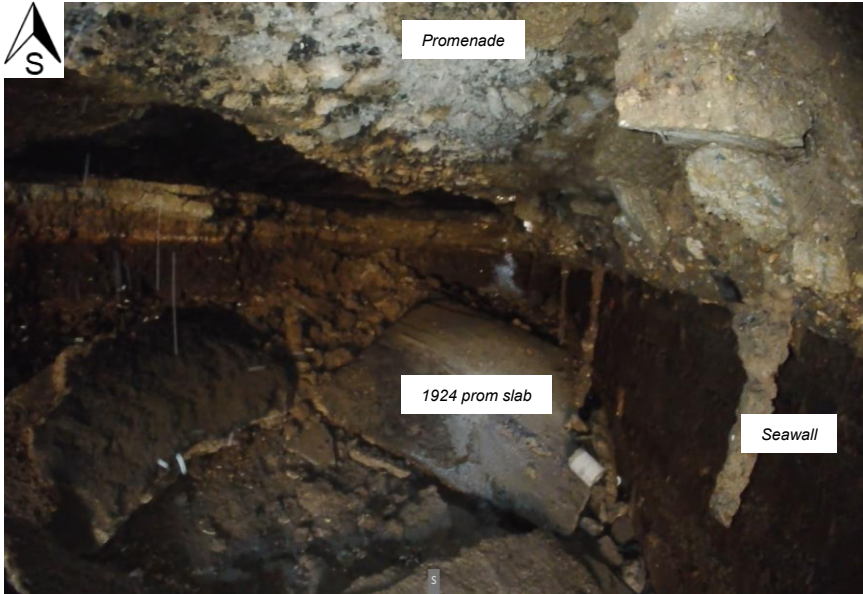
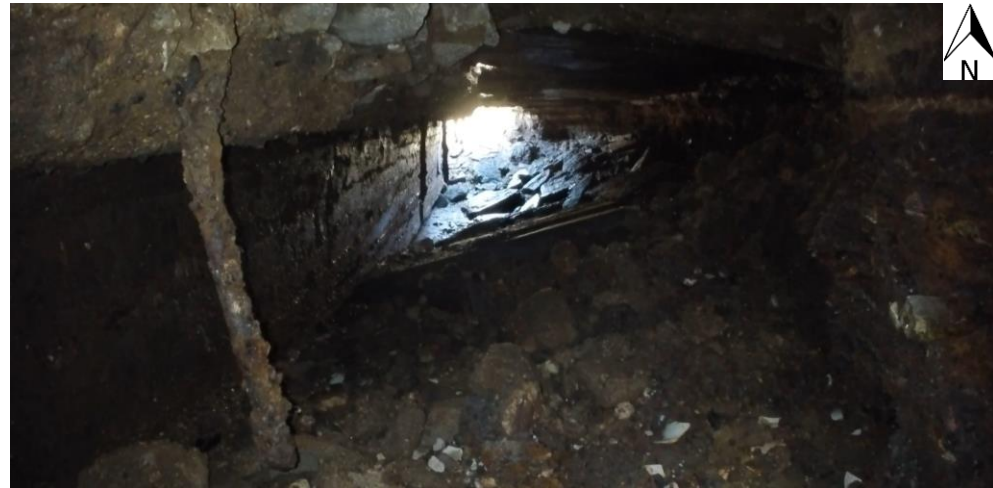
- While the hole in the asphalt promenade was approximately 1.5m long x 1.5m wide, the void beneath was much larger
- The final estimated size of the void was 26.5m long, 3.5m deep and 4m wide

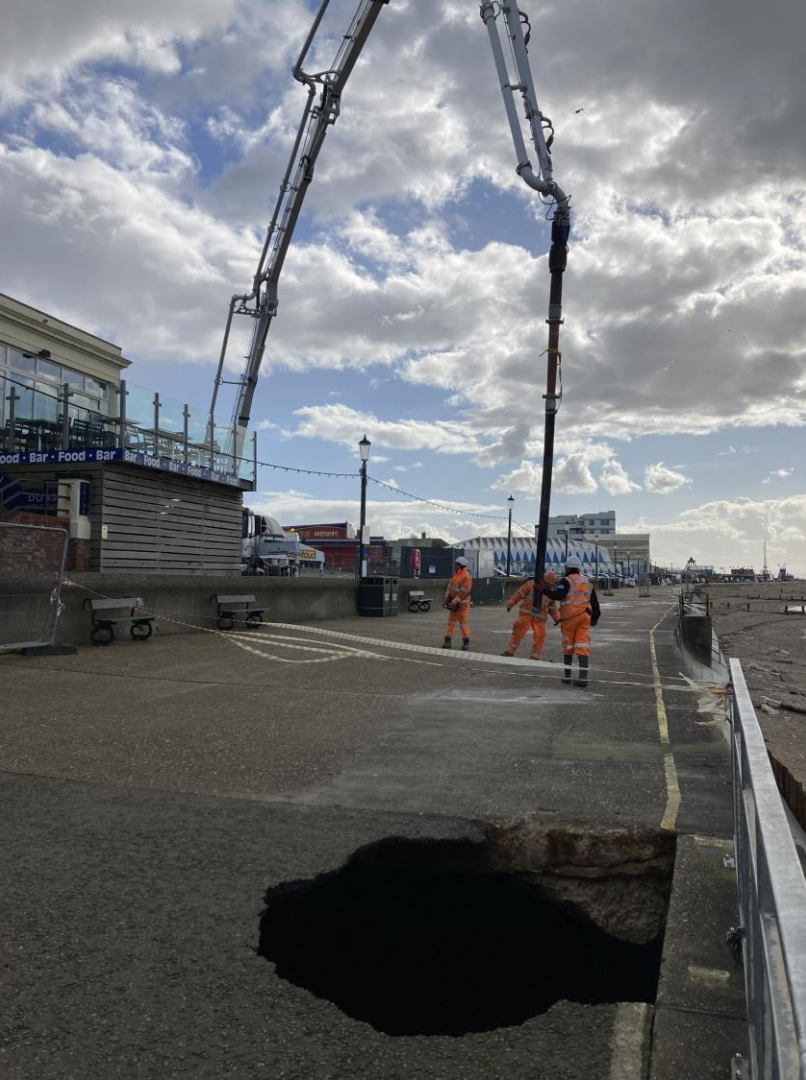
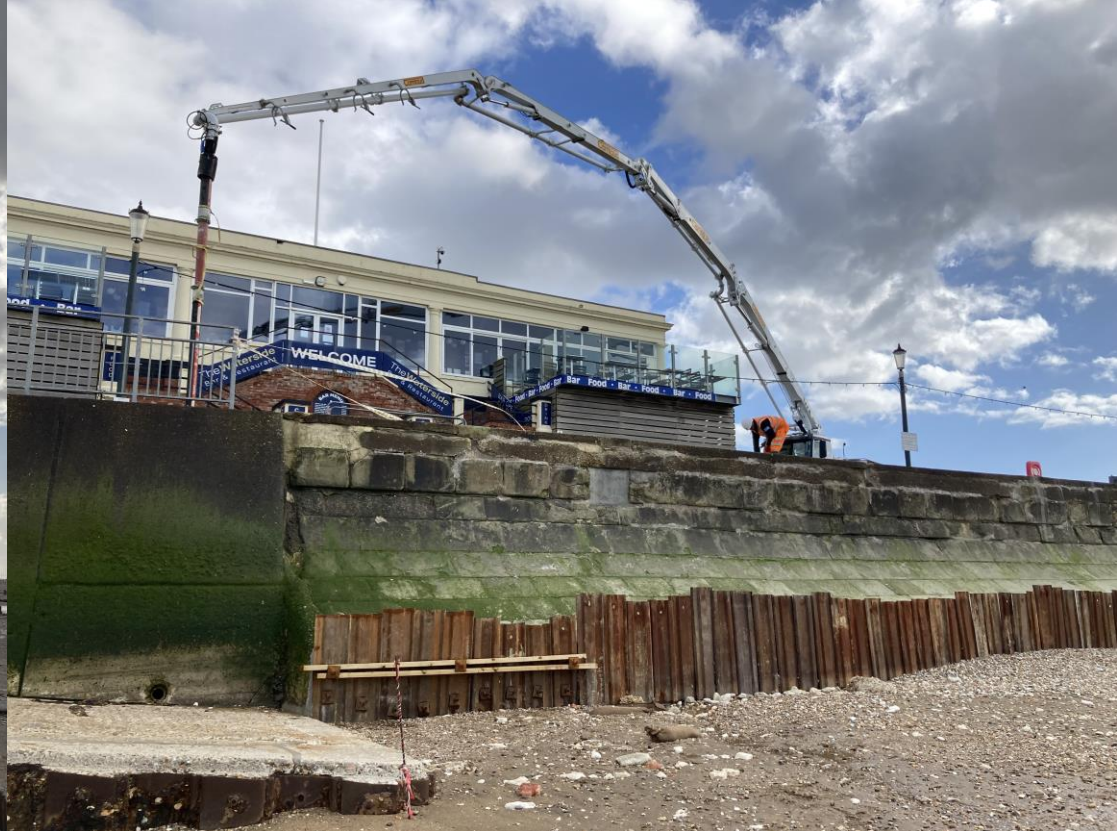
Underside of Prom Deck

Picture taken using  
Go Pro camera  
through core  
access hole

Section E Seawall reverse side

Concrete pour covering base of void  
and undermined wall

First pours of  
concrete

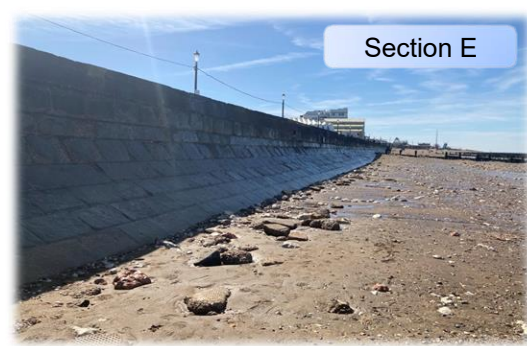
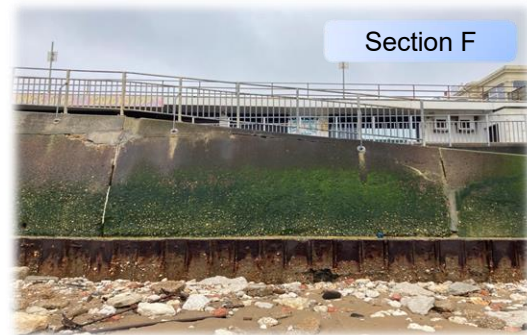
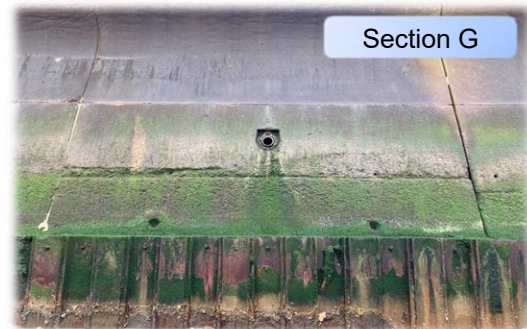
- The concrete promenade deck has poor structural condition and voids beneath it and requires replacement
- Seawall Section E is at risk of undermining if beach levels lower further and requires toe protection (sheet pile) installation and a seawall reface to mitigate future risk of undermining failure.
- Seawall Sections F and G are at risk of structural failure if beach levels lower further and require toe protection (sheet pile) installation and a seawall reface to mitigate future risk of structural failure.

**We now need to move away from a ‘patch and mend’ approach to a capital works rebuild of aspects of the coastal defences. This is to ensure they continue to provide their intended standard of protection.**
