# Hunstanton Coastal Defences Update

Dave Robson & Jade Kite  
April 2026

Borough Council of  
**King's Lynn &  
West Norfolk**

# Hunstanton Emergency Repair Works

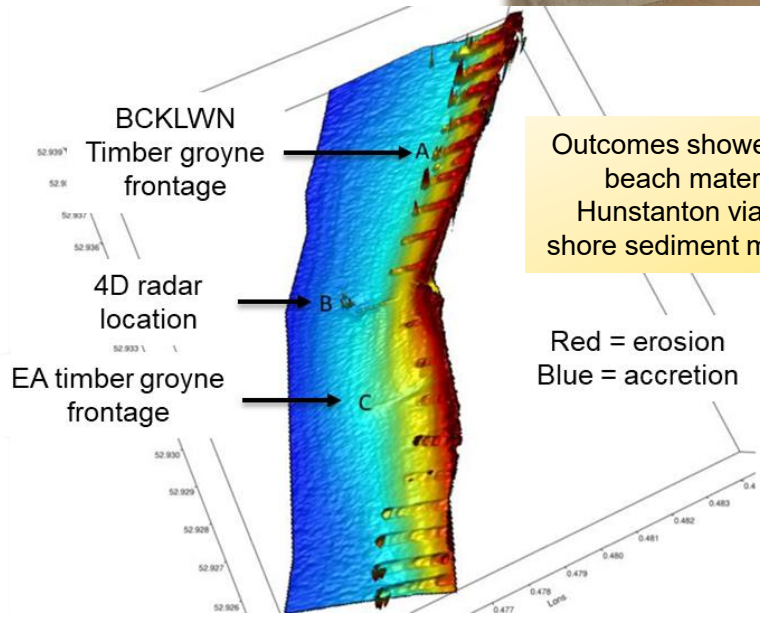
Outcomes showed loss of beach material at Hunstanton via cross-shore sediment movement

Red = erosion  
Blue = accretion

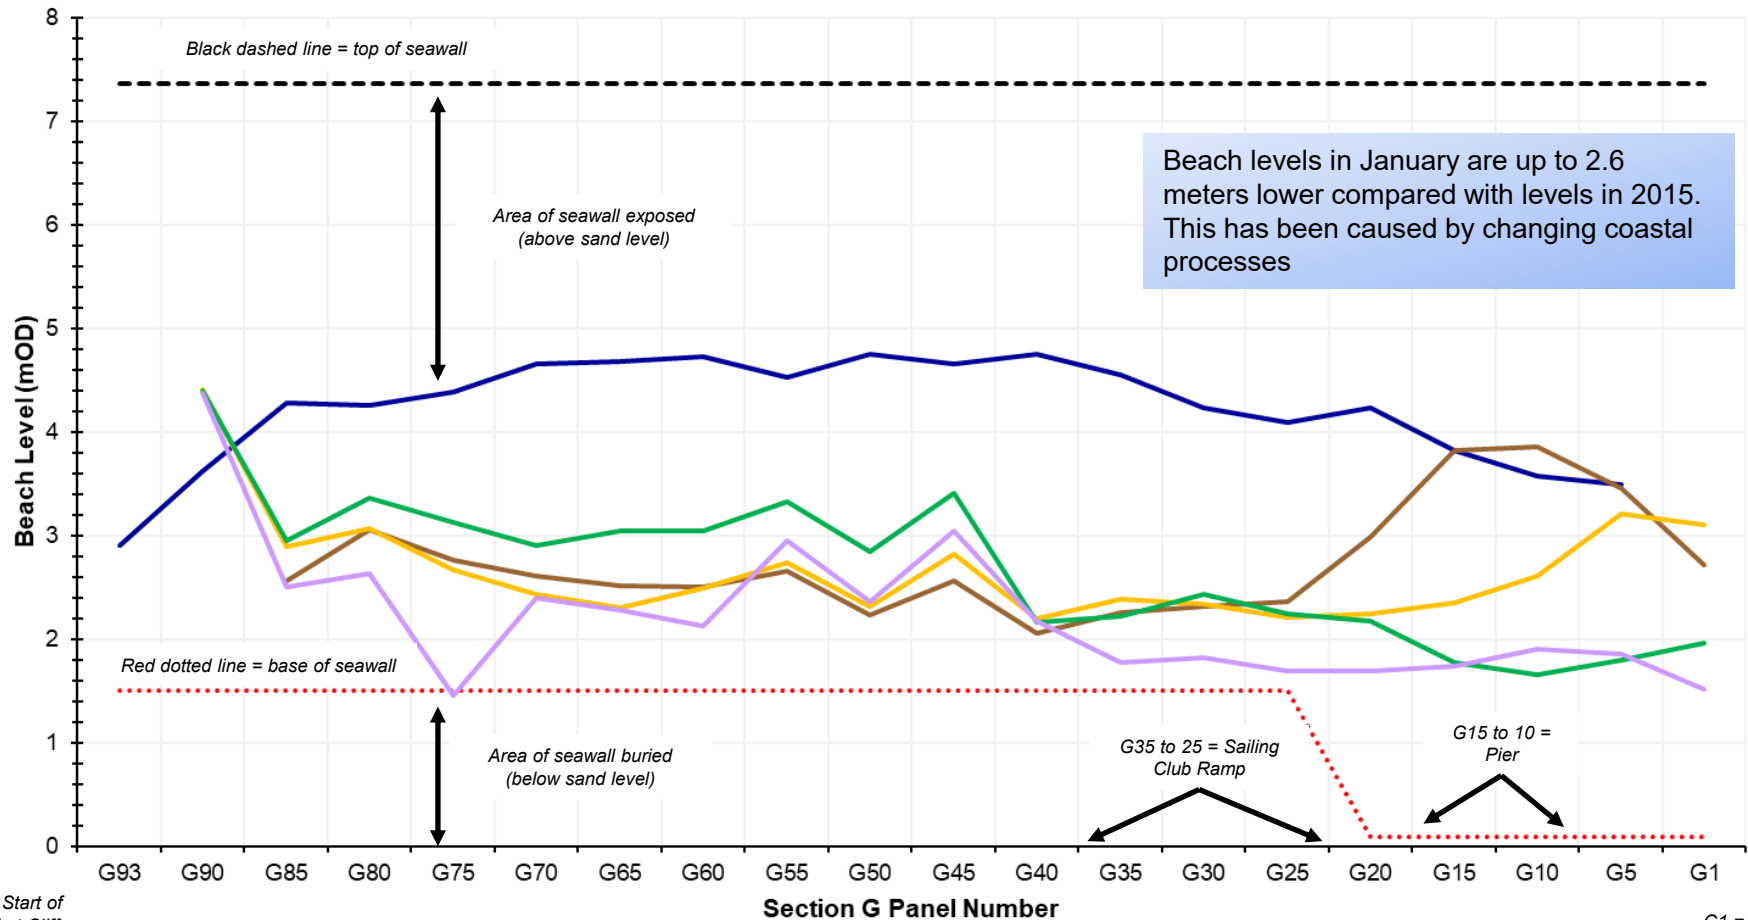
# Section G Beach Levels

Coloured lines = Height of beach material against the base of the seawall

G93 = Start of seawall at Cliffs

G1 = End of seawall ramp

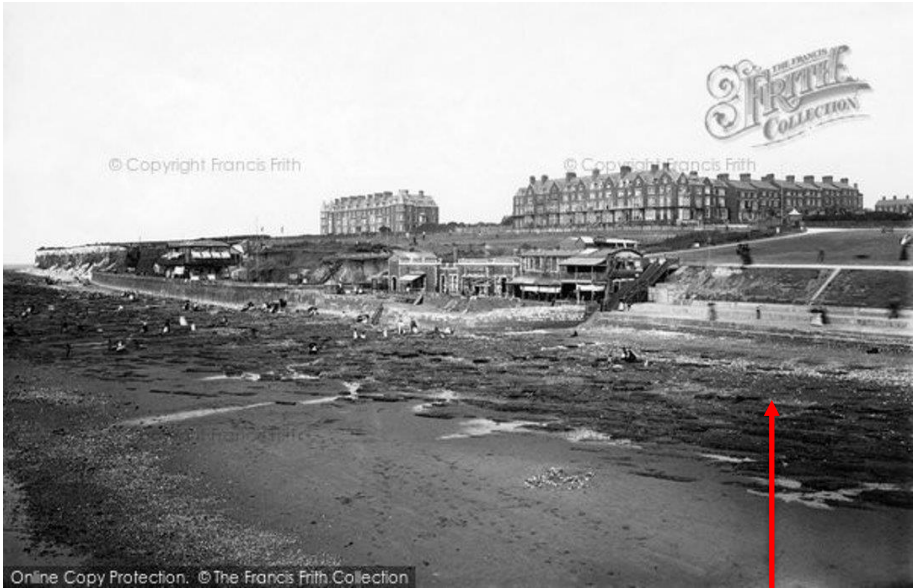
**Hunstanton in 1893**

Widespread Carstone exposure and limited beach cover is evident

Beach conditions between 1893-1907 look very similar to today

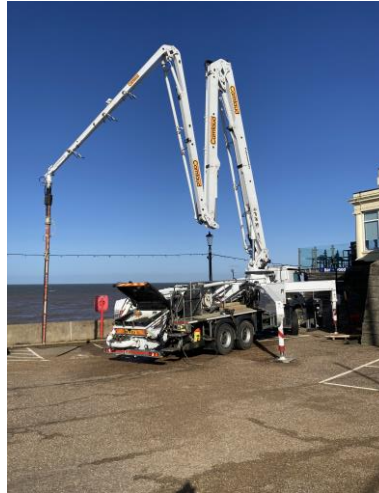
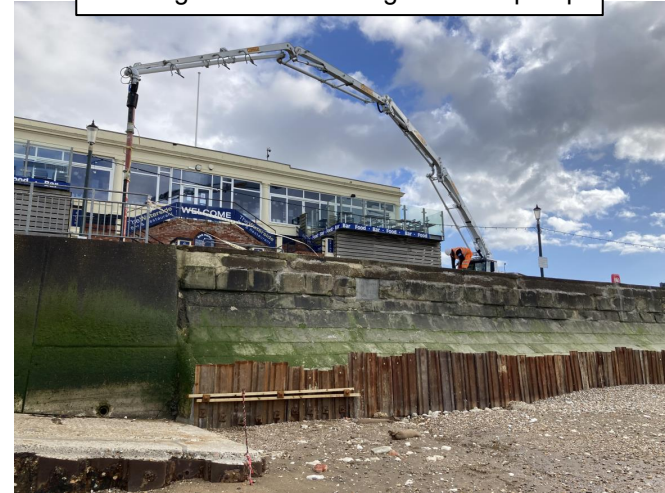
Underside of Prom Deck

Picture taken using  
Go Pro camera  
through core  
access hole

Section E Seawall reverse side

Concrete pour covering base of void  
and undermined wall

First pours of  
concrete

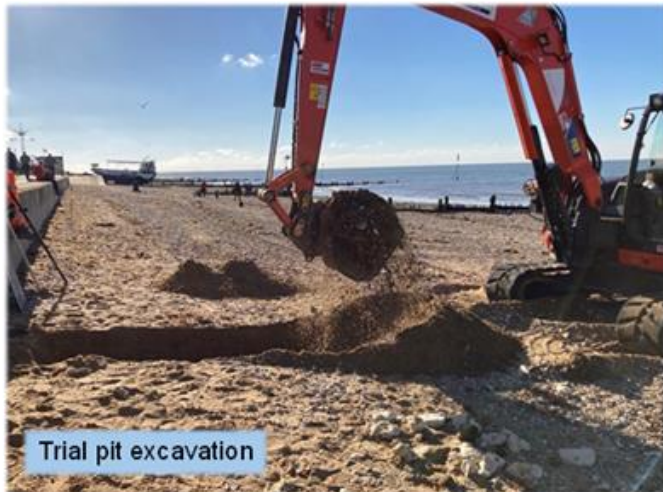
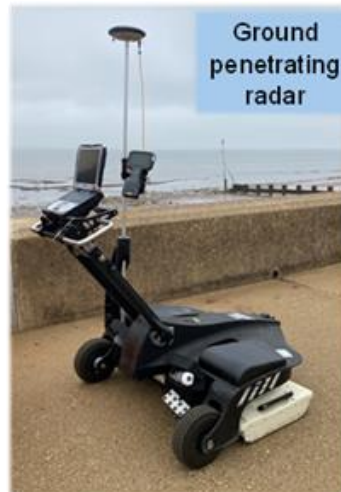
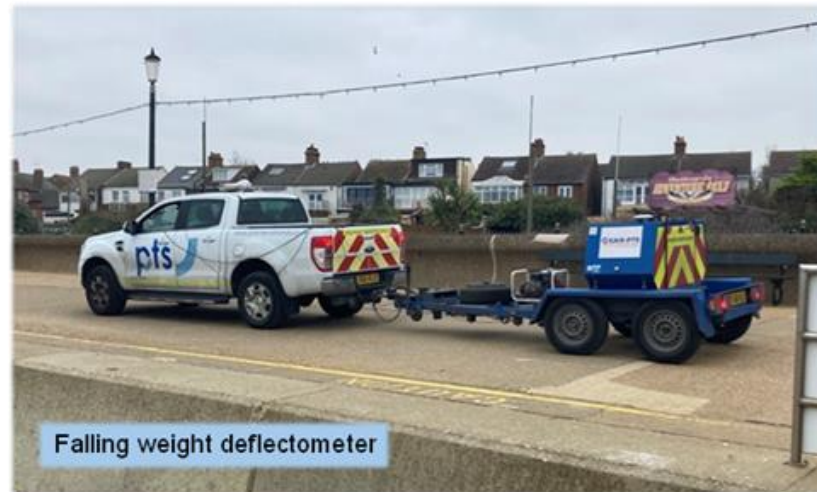
# Geotechnical Investigation

- Excavation of 25 trial pits along the base of the seawall to expose the conditions seawall foundations which are normally buried beneath beach material.
- A ground penetrating radar survey to assess the internal condition of the promenade deck
- A falling weight deflectometer to test the material strength of the concrete promenade deck
- On site investigations were completed in Autumn 2024, and a final report of outcomes received in July 2025

- The concrete promenade deck has poor structural condition and voids beneath it and requires replacement
- Seawall Section E is at risk of undermining if beach levels lower further and requires toe protection (sheet pile) installation and a seawall reface to mitigate future risk of undermining failure.
- Seawall Sections F and G are at risk of structural failure if beach levels lower further and require toe protection (sheet pile) installation and a seawall reface to mitigate future risk of structural failure.

**We now need to move away from a ‘patch and mend’ approach to a capital works rebuild of aspects of the coastal defences. This is to ensure they continue to provide their intended standard of protection.**
